WISCONSIN FACE INVESTIGATION

SUBJECT: Public Works Laborer Caught in Auger of Truck Sander

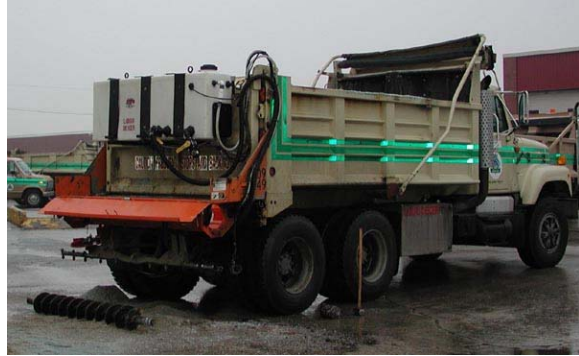
On December 30, 2002, a 51- year- old laborer (the victim) at a city public works department died after his arm or clothing was caught in the auger of a truck sander (Figure 1). He was alone at the time of the incident and was found with this arm wrapped around the auger and his feet about 4 feet above the ground. When his co-workers found him, he had no pulse and was not breathing. The victim was freed from the auger and paramedics transported him to the hospital, where he was pronounced dead. FACE investigators concluded that, to help prevent similar occurrences, employers should:

Figure 1. View of Dump Truck with Spreader Attachment; Auger on Ground

Recommendation #1: Ensure that augers are shielded at all times while operating to prevent worker contact with rotating machine parts.

Discussion: The auger for the spreader attachment was located in the base of the spreader box. A hinged metal plate shielded the auger during operation, but could be released and dropped down whether or not the auger was running. The victim released the metal plate that was shielding the auger but did not turn the auger off while he apparently reached over the auger to clear sand from the deck. Interlock systems can be installed to prevent machines from operating whenever the guard or shield is not in place.

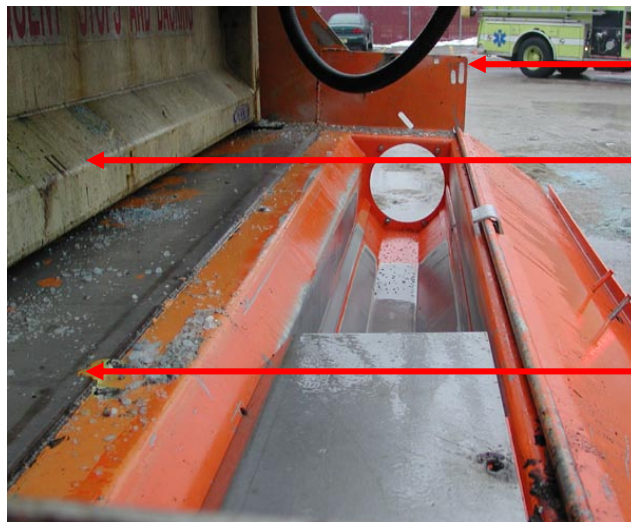
auger box so he could access the 10-inch wide “bench” to wipe sand off (Figure 2). While the auger was still running, he apparently reached across it to clear the bench. It is unknown if the victim fell into the auger, or if his clothing or hand was caught by the revolving auger as he reached across it.

Latch-Pin Holes for Drop-down Plate

Dump Box Tailgate. Tailgate does not close if sand is present on Bench.

Bench Area Where Sand Accumulates. Victim was Wiping Sand When Incident Occurred.

Figure 2. Photo from Left Side of Sander

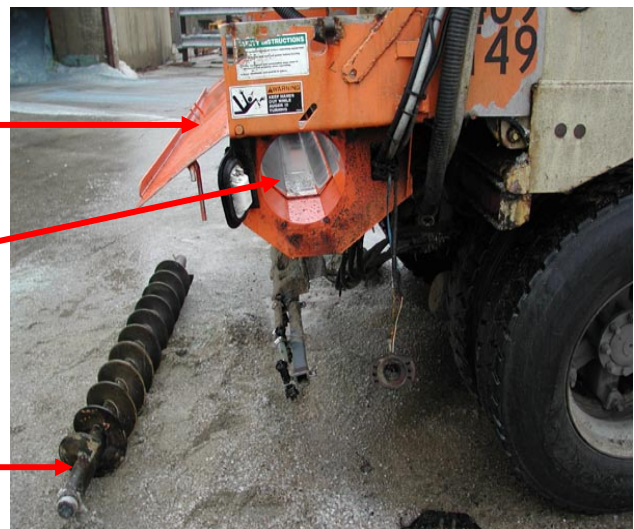
Drop-down Plate for Spreader Box.

Auger Sleeve

Auger Removed During Rescue

Figure 3. Photo of Right Side of Sander
